UNITED STATES ENVIRONMENTAL PROTECTION AGENCY  
REGION 8

Re: Animal Feeding Operation Inspection at Wilder Buffalo Ranch, McLaughlin, SD and  
Request for Information Pursuant to § 308 of the Clean Water Act

## Water Compliance Inspection Report

## ANIMAL FEEDING OPERATION INSPECTION REPORT

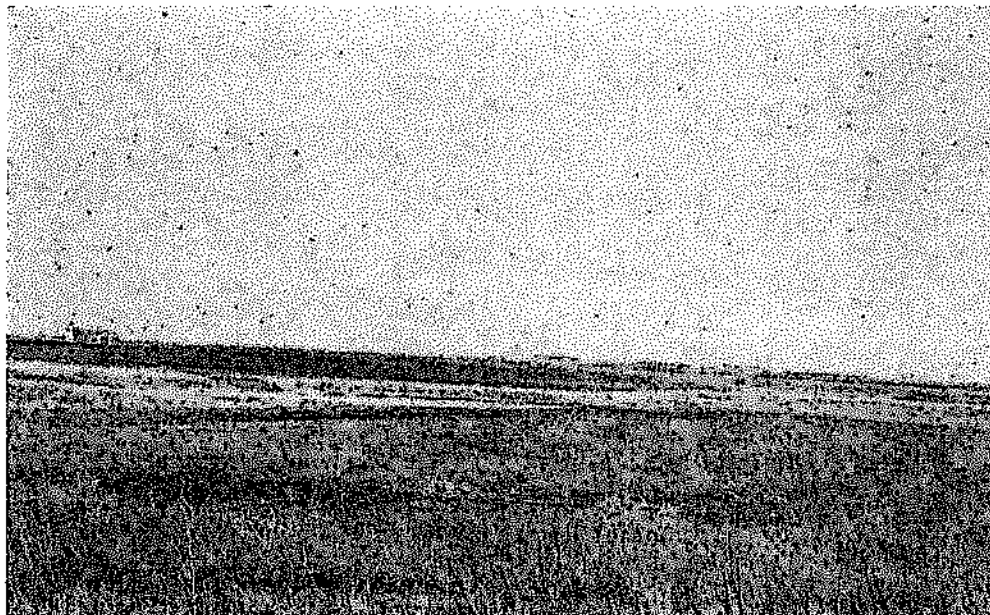
*Photo Number* 117

*Description* Looking southwest below west pens. Note area of dried manure in center of photo.

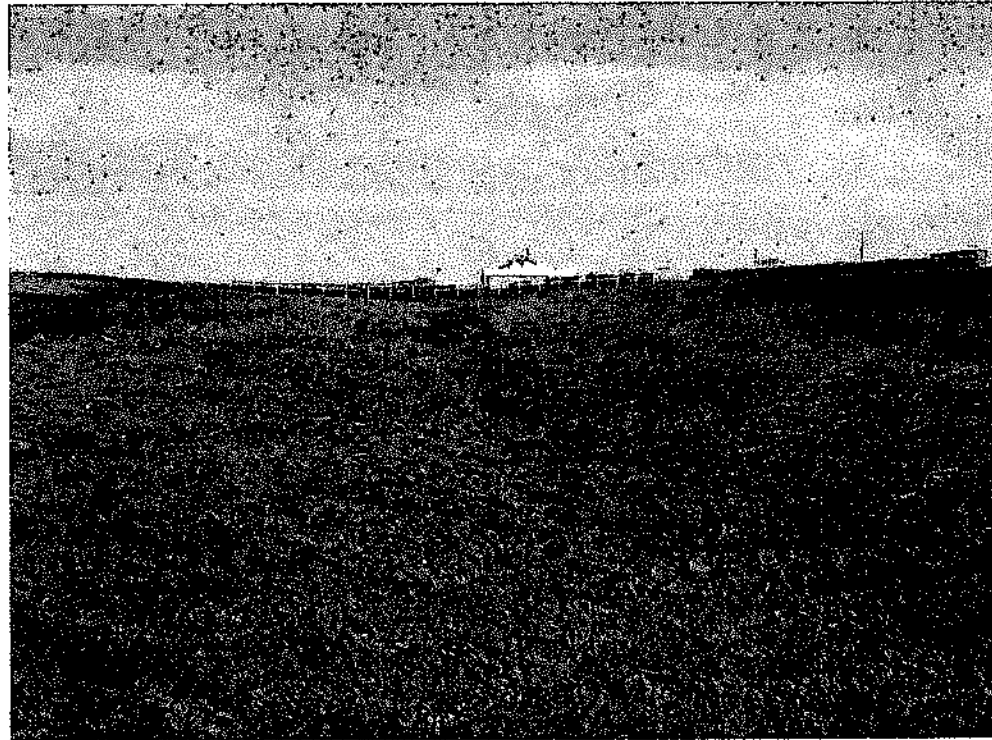
*Description* Looking north at east pens, showing washout channel and manure leaving the site.

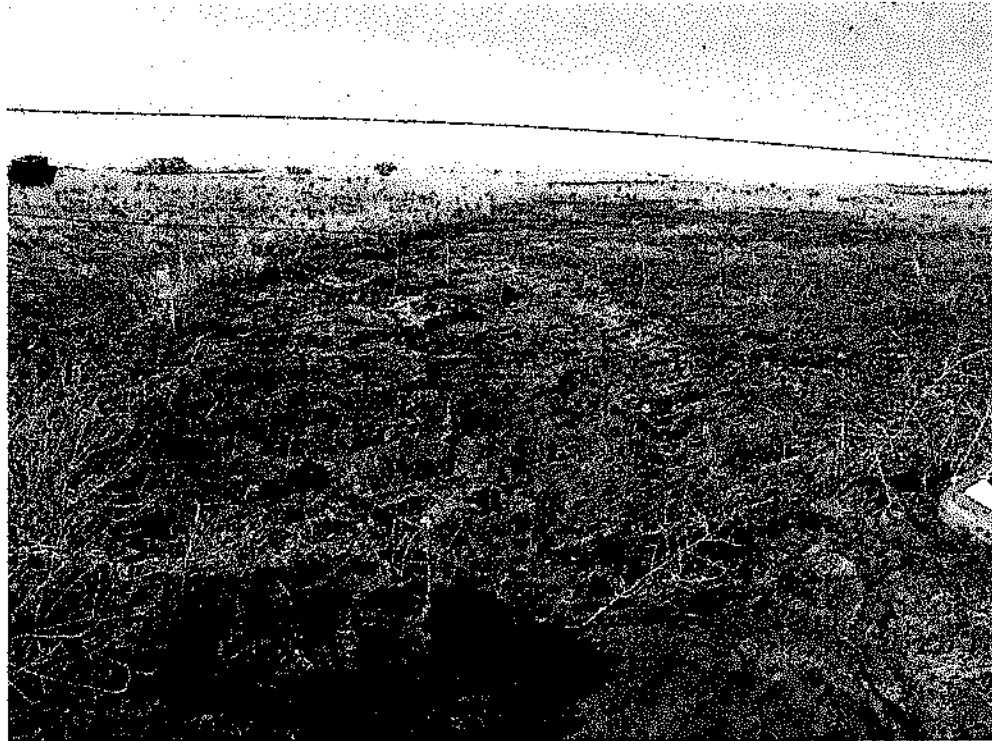
*Description* Looking south from east pens, showing washout channel and manure leaving the site at the section fenceline. Flow is in a south/southwestern direction.

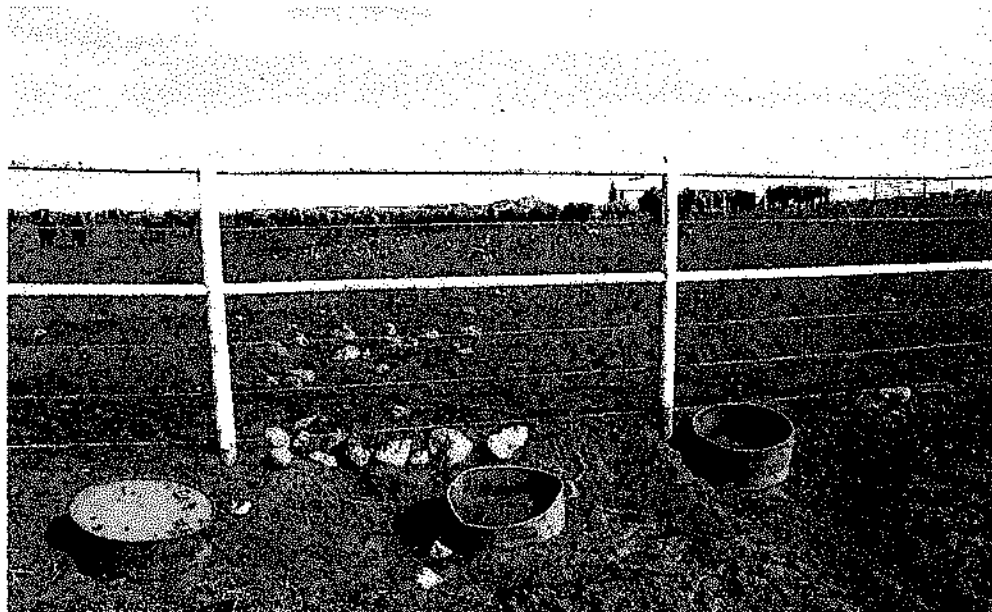
*Photo Number* 123

*Description* Half drums, and dirt/rocks pushed up to the south end of the east pens.

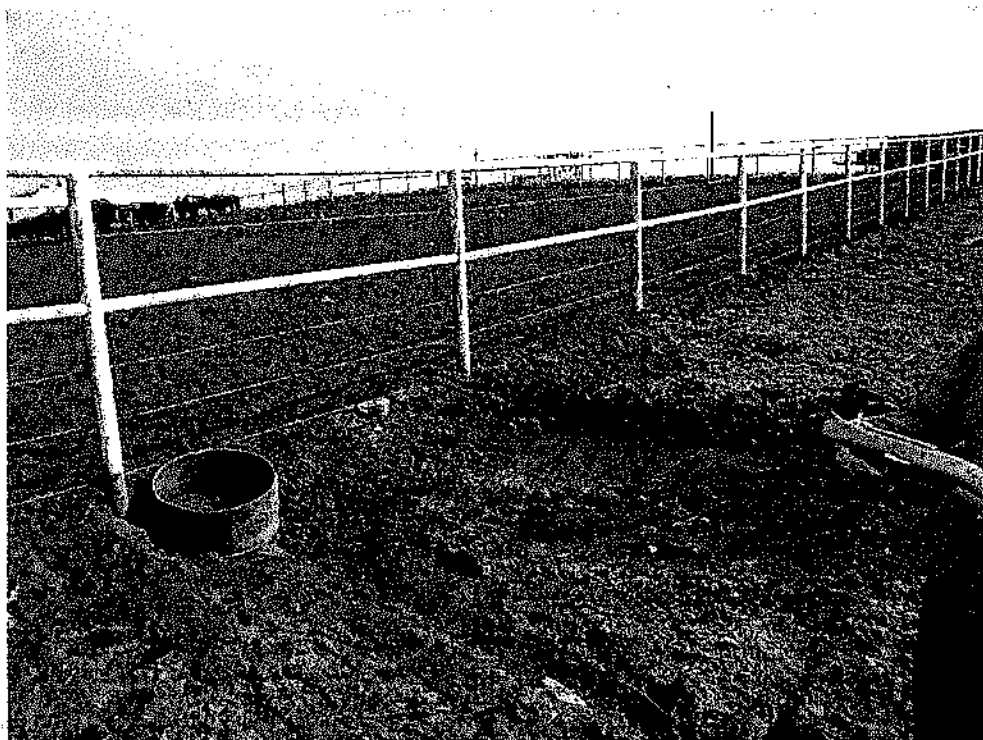
*Description* Half drums and dirt recently pushed up to the south end of the east pens.

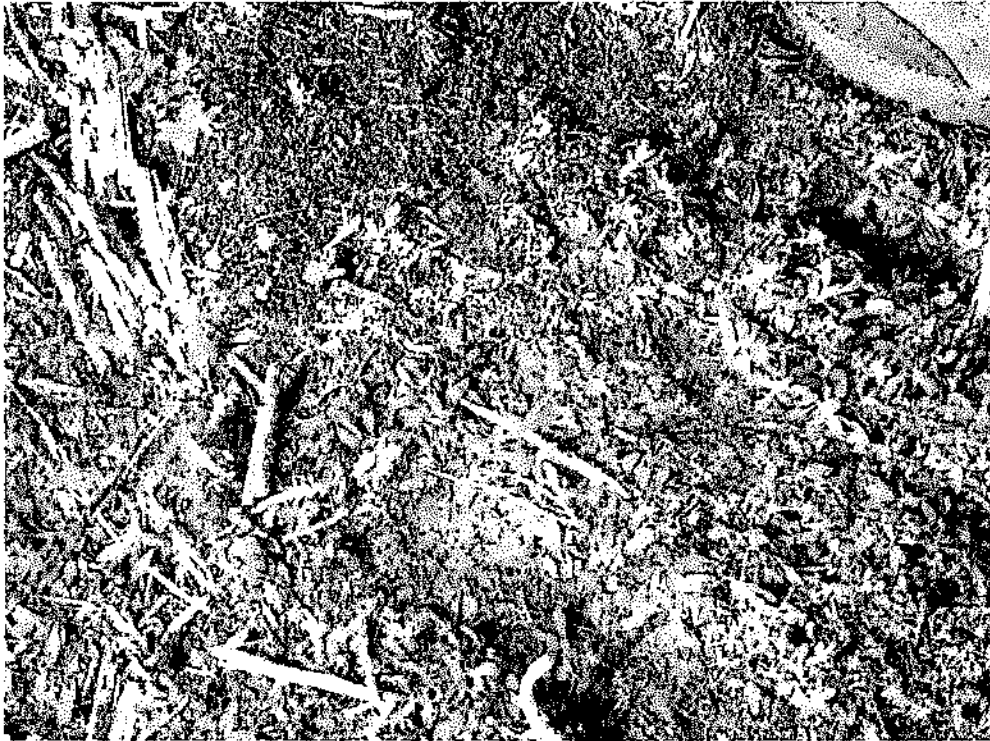
*Description* Close-up of ground at the south end of the east pens showing recent deposition of manure.

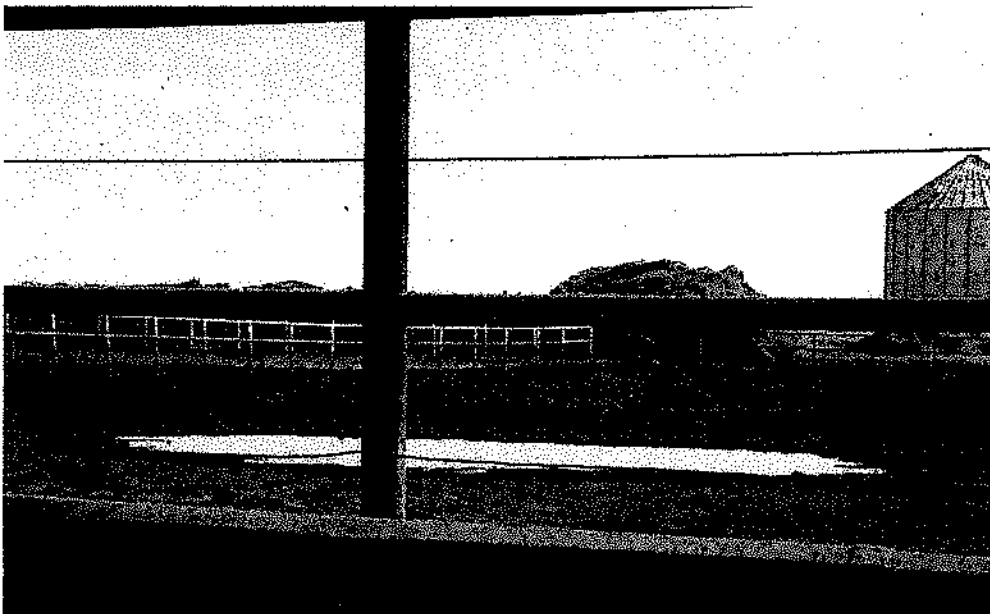
*Photo Number* 127

*Description* Ponding of water in the middle of the east pens.

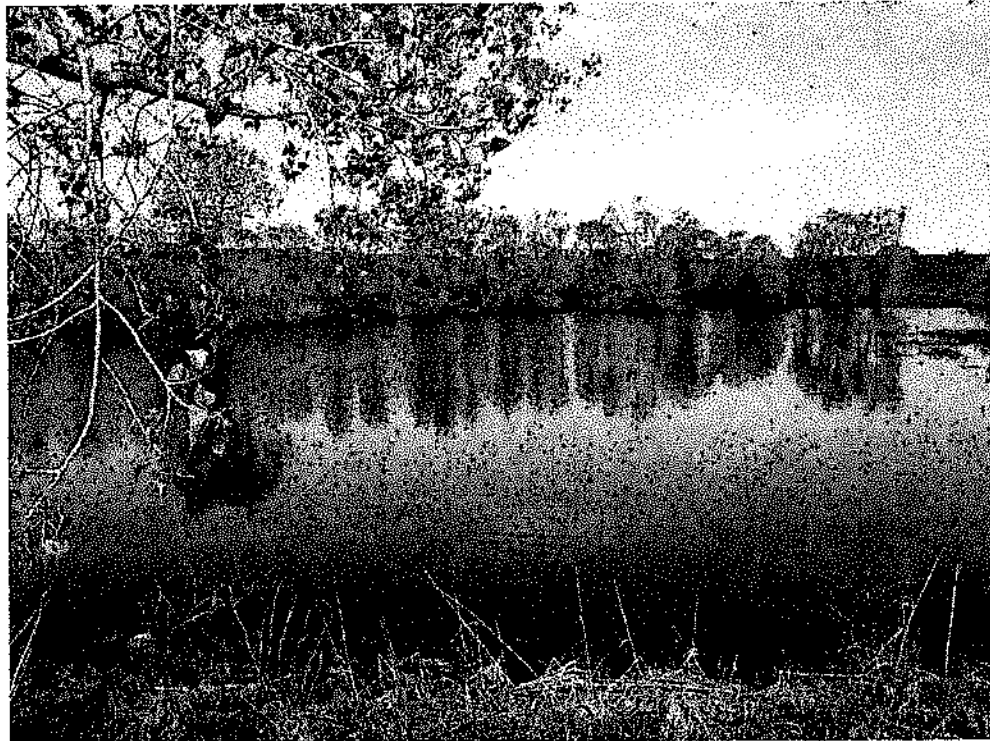
*Description* Freshwater pond located east, and over the hill from the facility area. Outlet from the pond shows recent erosion, but water appears to flow to the southeast, and does not enter the feedlot area.

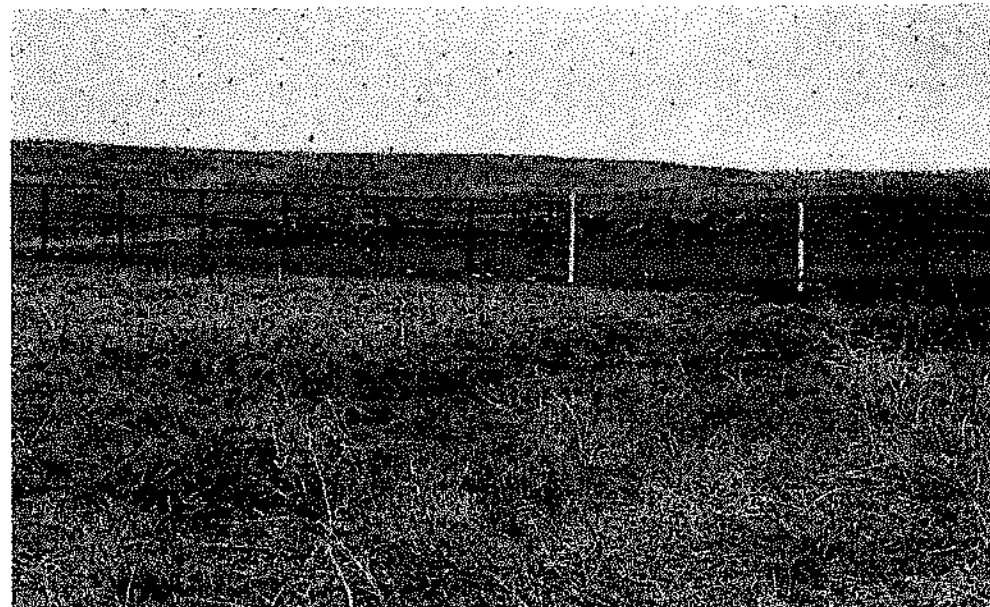
*Photo Number* 129

*Description* South end of west pens looking northwest. Some manure present on ground outside of the pen area.

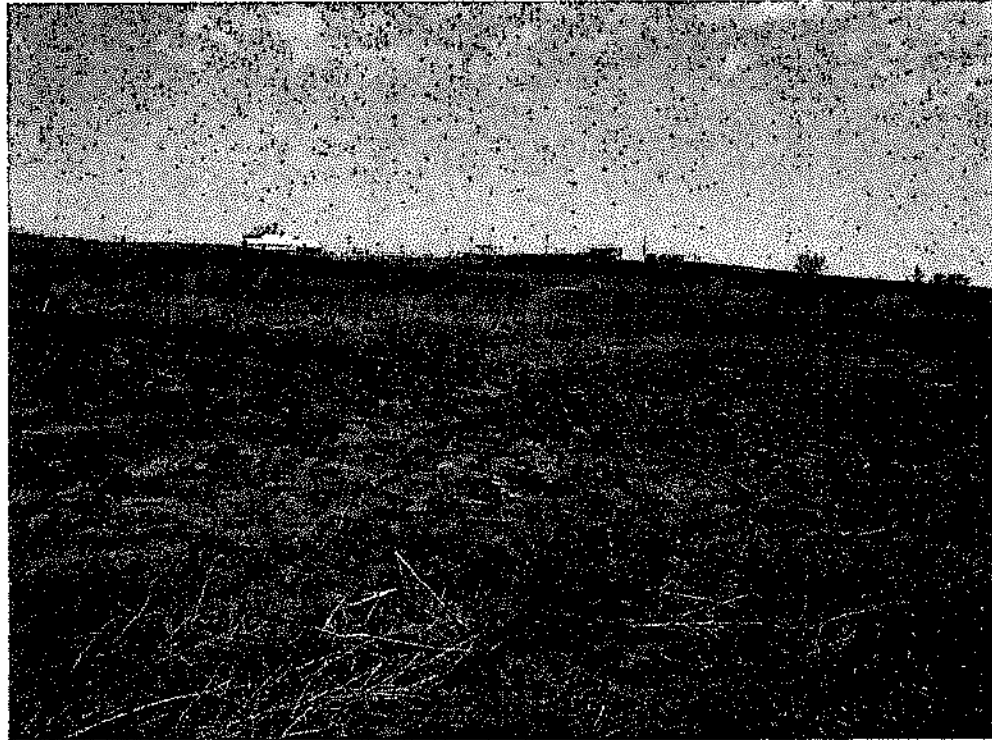
*Description* Area below section fence line, looking north east at feedlot area, showing overland flow of manure from the east pens.

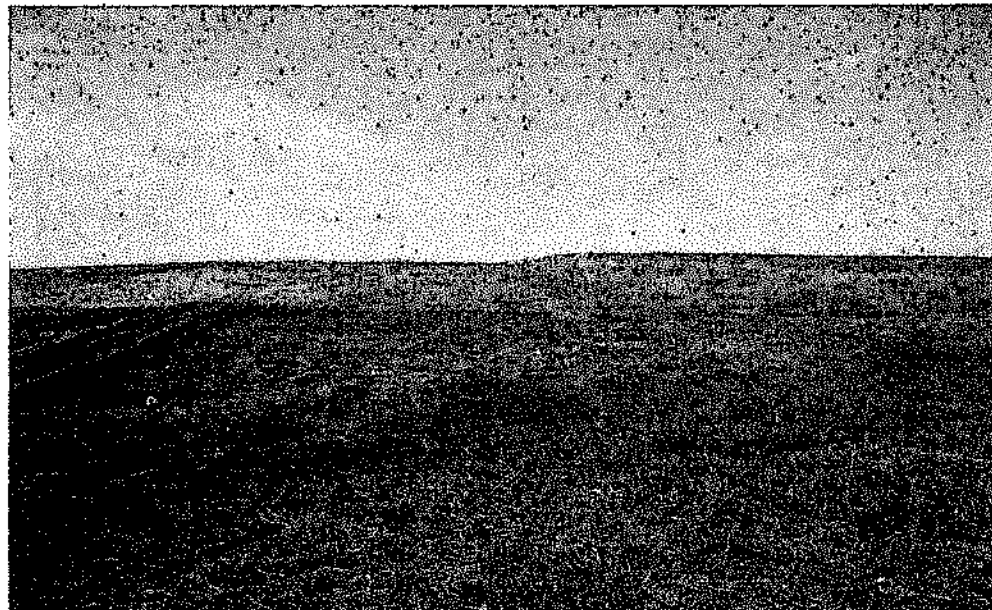
*Photo Number* 131

*Description* Looking west below section fenceline, showing overland flow of manure, and fresh tire tracks over flow area.

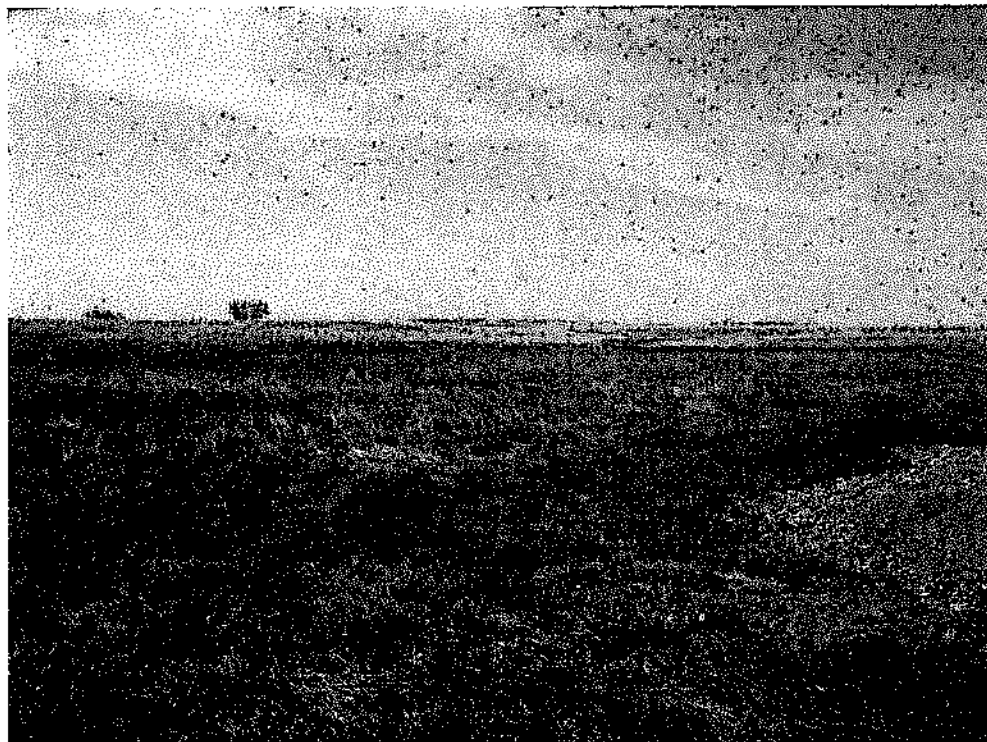
*Description* Looking southwest from mortality pit, showing continuing south/southwestern overland flow of manure from feedlots.

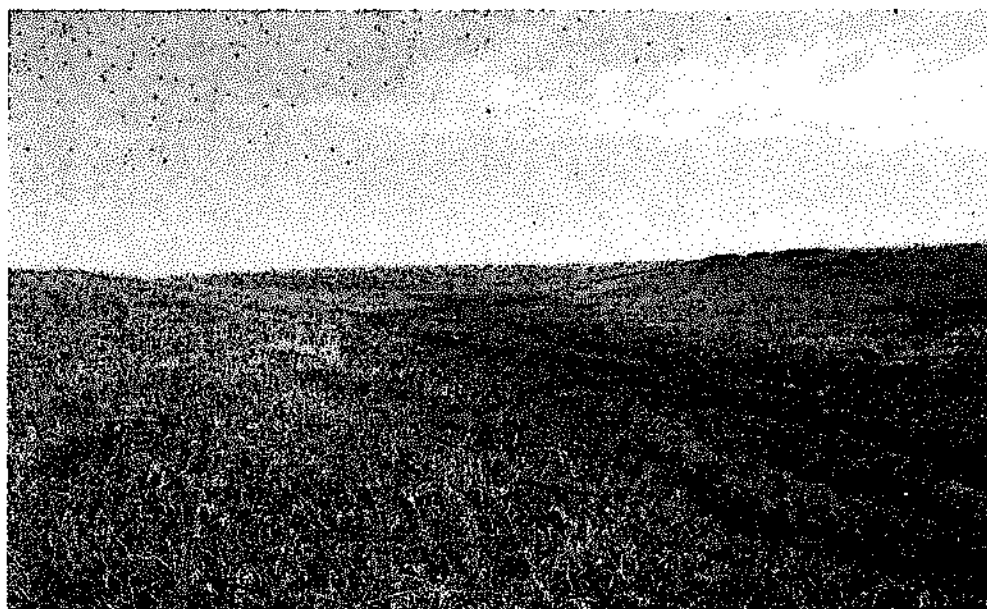
*Photo Number* 138

*Description* Looking north approximately one mile from the feedlots, showing channeled manure flow to the south.

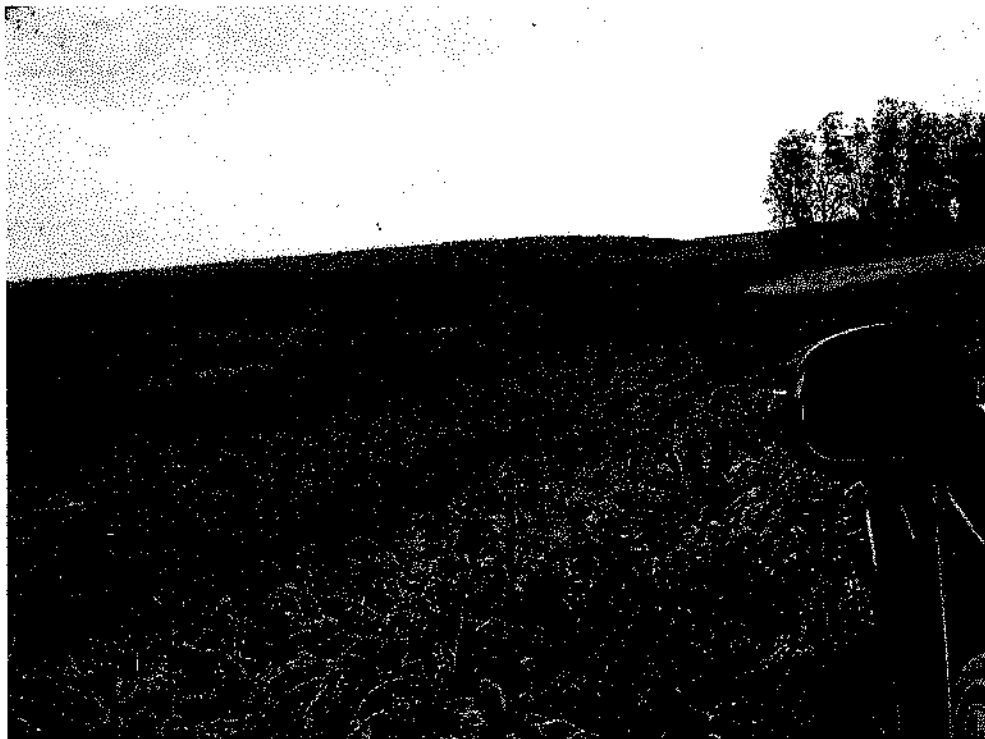
*Description* Looking southeast at  
channeled manure  
flow, approximately  
one mile from the  
feedlots. Trees are  
located at pond area  
at the mouth of the  
channel.

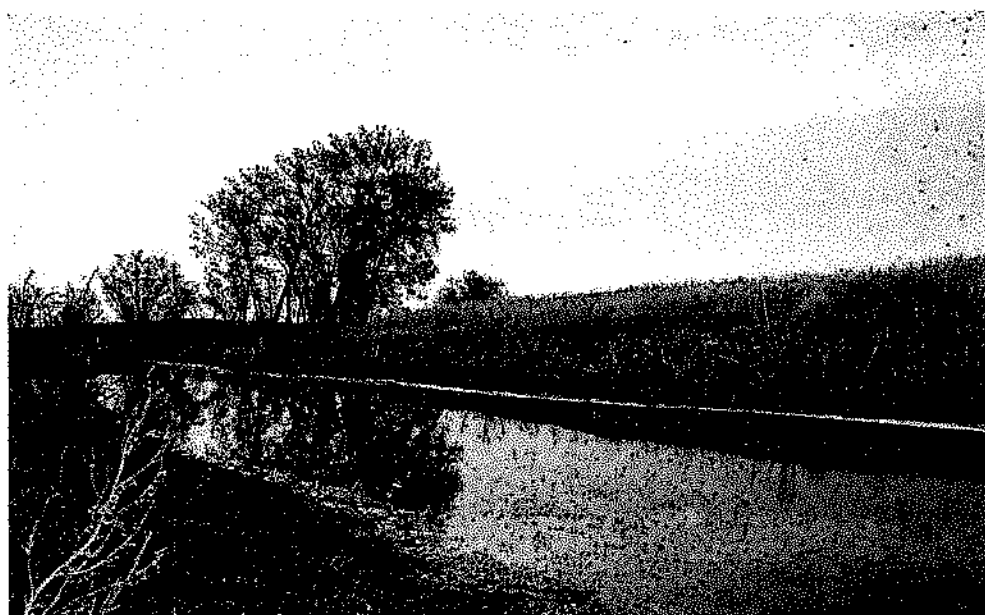
*Photo Number* 140

A pond is located in the pasture across the state road from the facility (Photos 144, 145, and 146). Another pond is located over the hill from the facility approximately 0.25 miles away (Photo 128), and it did not appear that it would receive runoff from the confinement pens. A pond (not on Wilder Ranch property) located 1 ¼ miles south of the confinement pens appeared to collect wastewater runoff from the facility through a natural channel (Photos 140 and 141).

*Description* Pond located  
approximately 1.25  
miles from feedlots,  
at the end of manure  
flow channel, looking  
southeast. Pond  
appeared to be  
septic.

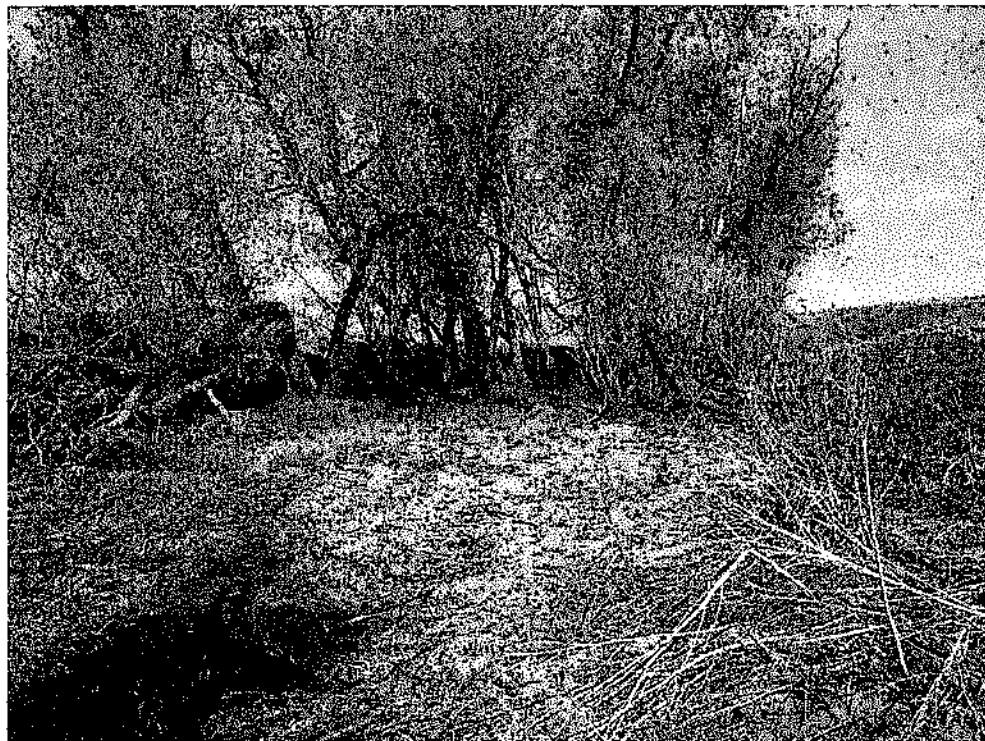
*Description* Looking northwest at the mouth of the manure flow channel entering the septic pond. Pond is located approximately 1.25 miles from feedlots.

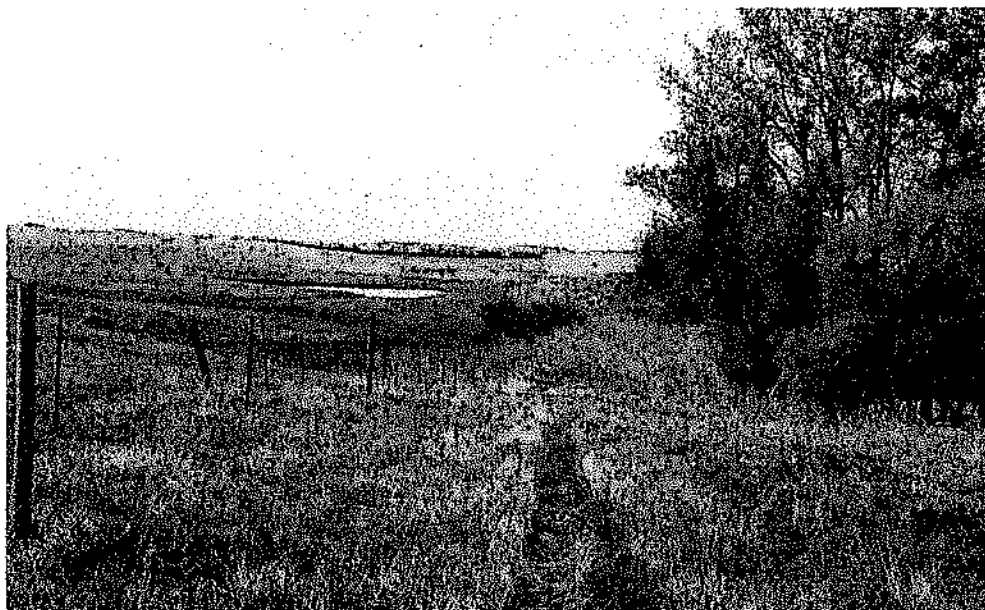
*Photo Number* 142

*Description* Looking south at eastern edge of septic pond in Photos 140 and 141, towards drainage to another pond off of the property.

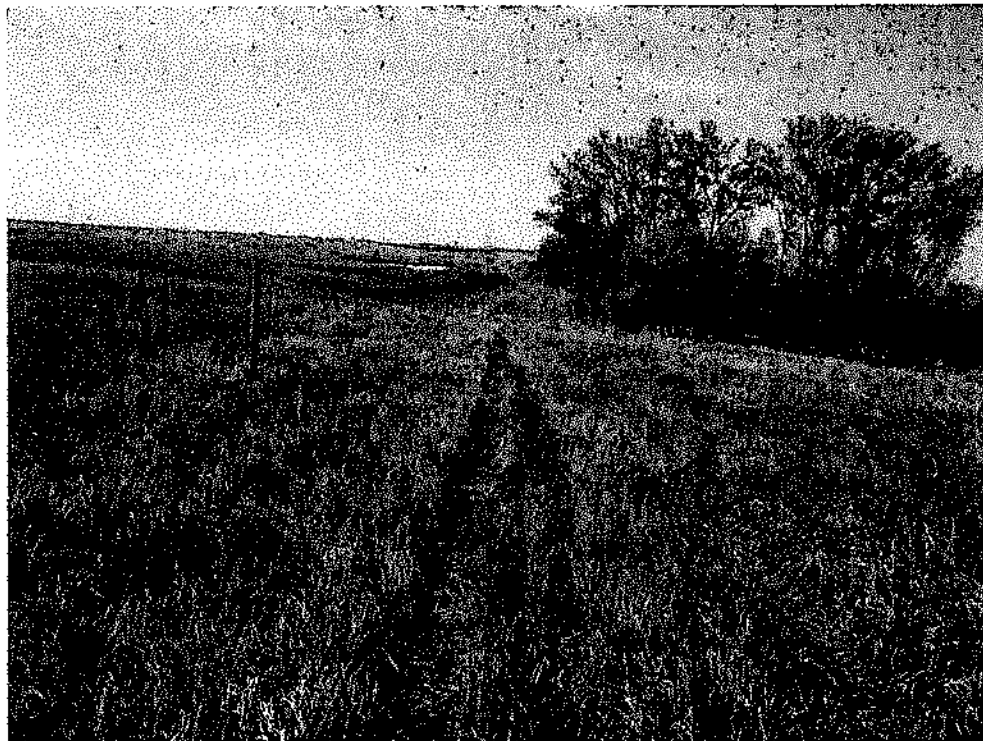
*Description* Looking south at eastern edge of septic pond in Photos 140 and 141, towards drainage to another pond off of the property.

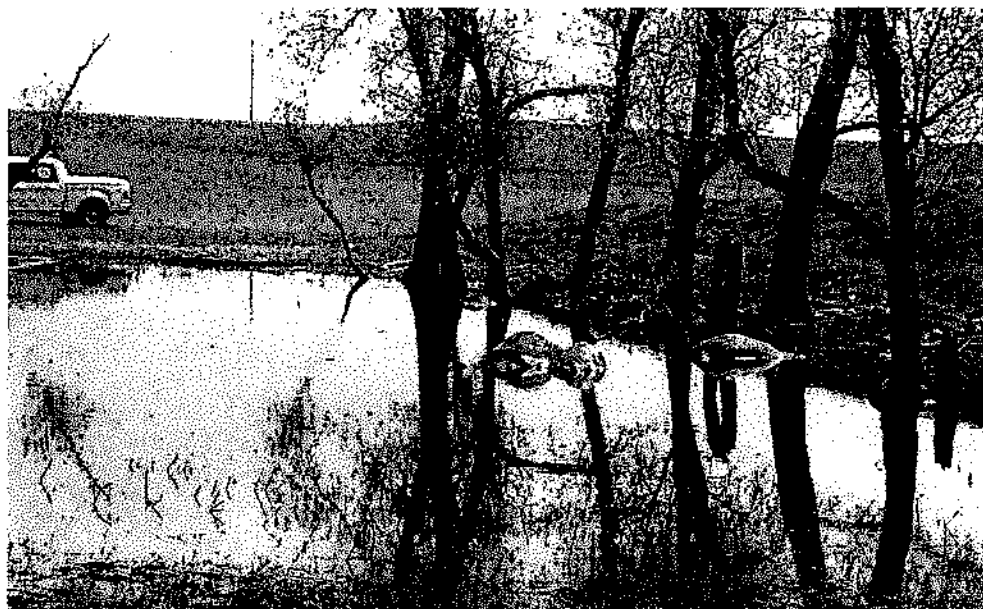
*Photo Number* 144

Mortalities were observed in the pasture area in a pond to the west of facility across the state highway.

*Description* Looking northeast at buffalo mortalities in pond located in pasture across road west of the feedlot area.

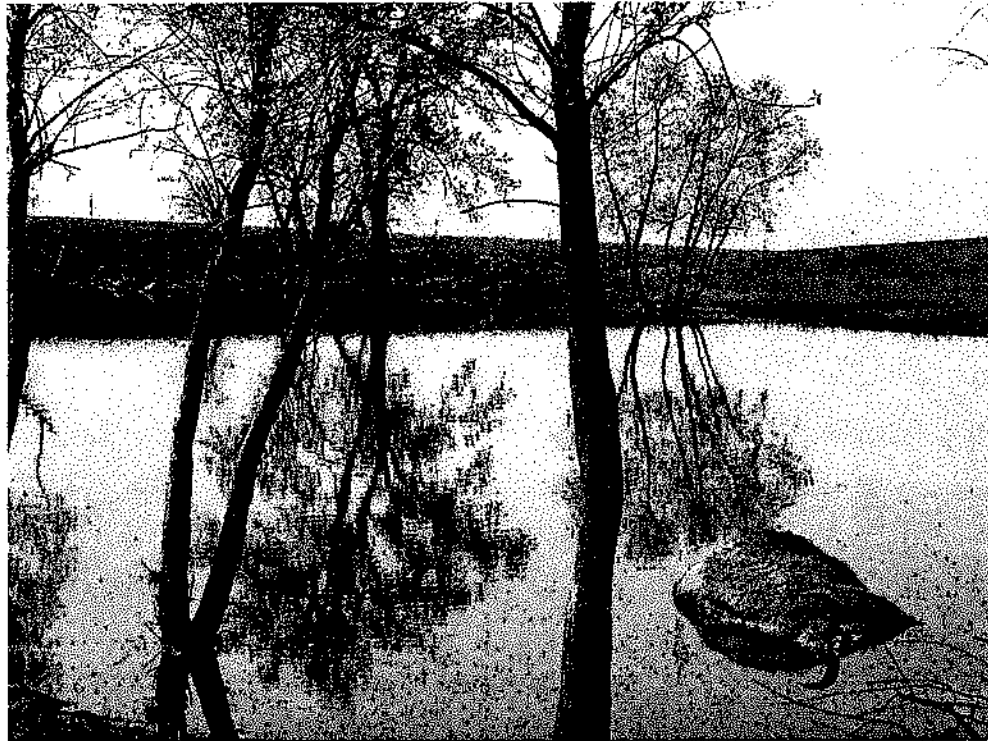
*Description* Looking southwest at buffalo mortalities in pond located in pasture across road west of the feedlot area.

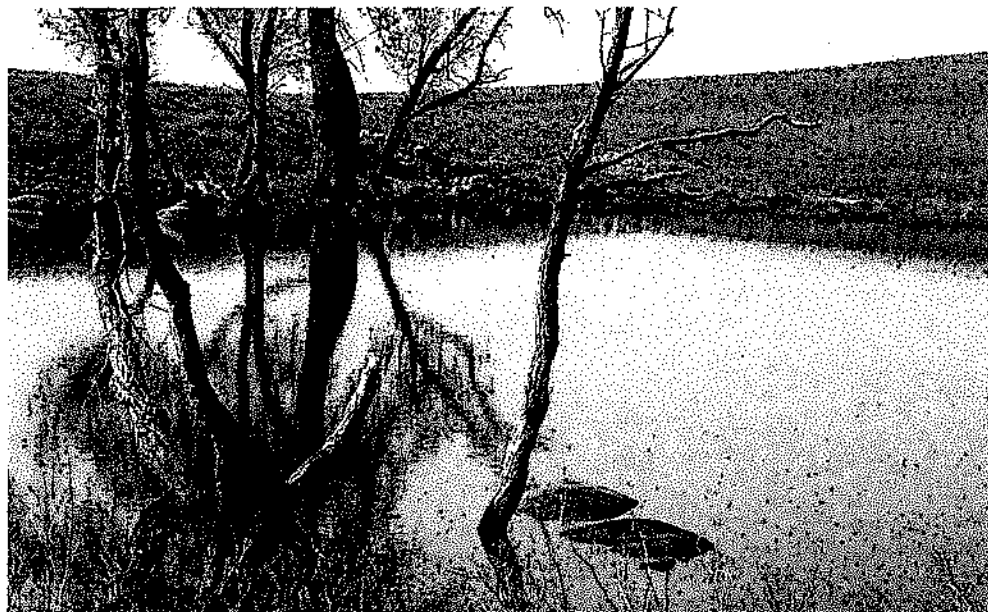
*Photo Number* 146

*Description* Looking southwest at buffalo mortalities in pond located in pasture across road west of the feedlot area.

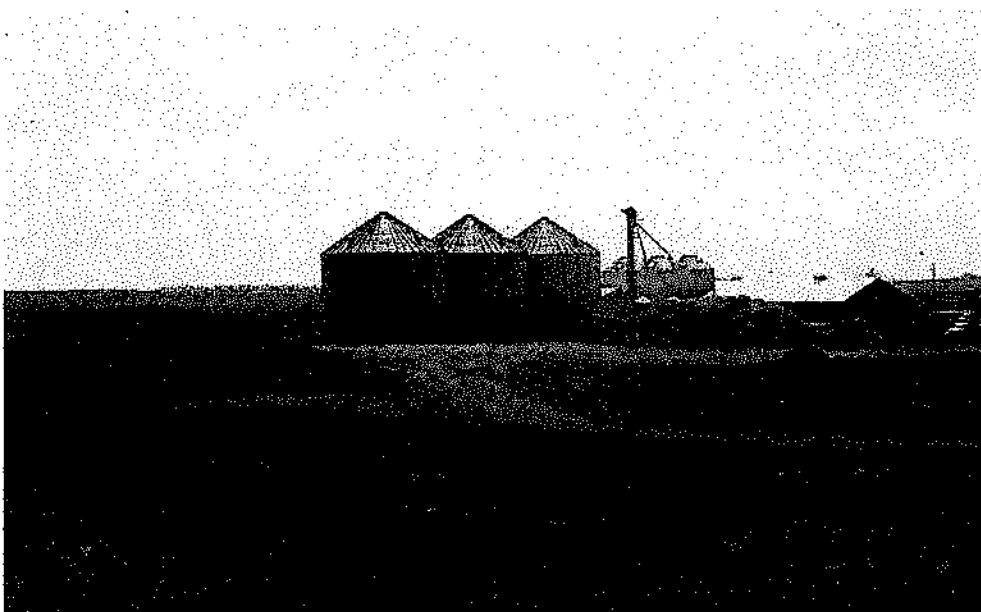
*Photo Number* 148

Manure pile was located next to access road into facility (See Photos 148 and 149). Manager reports that the manure is removed from the pens in the spring, and spread.

*Description* Looking east from the north road entering the facility, showing manure piles, feed bins, and hay storage.
